**Historical Aquatic Habitats in the White River Valley,
RM 5 – RM 28, King County, Washington**

**King County Department of Natural Resources and Parks
201 South Jackson Street
Seattle, WA 98104-3855**

**Brian D. Collins and Amir J. Sheikh
Department of Earth & Space Sciences
Box 351310, University of Washington
Seattle, WA 98195**

December 1, 2004

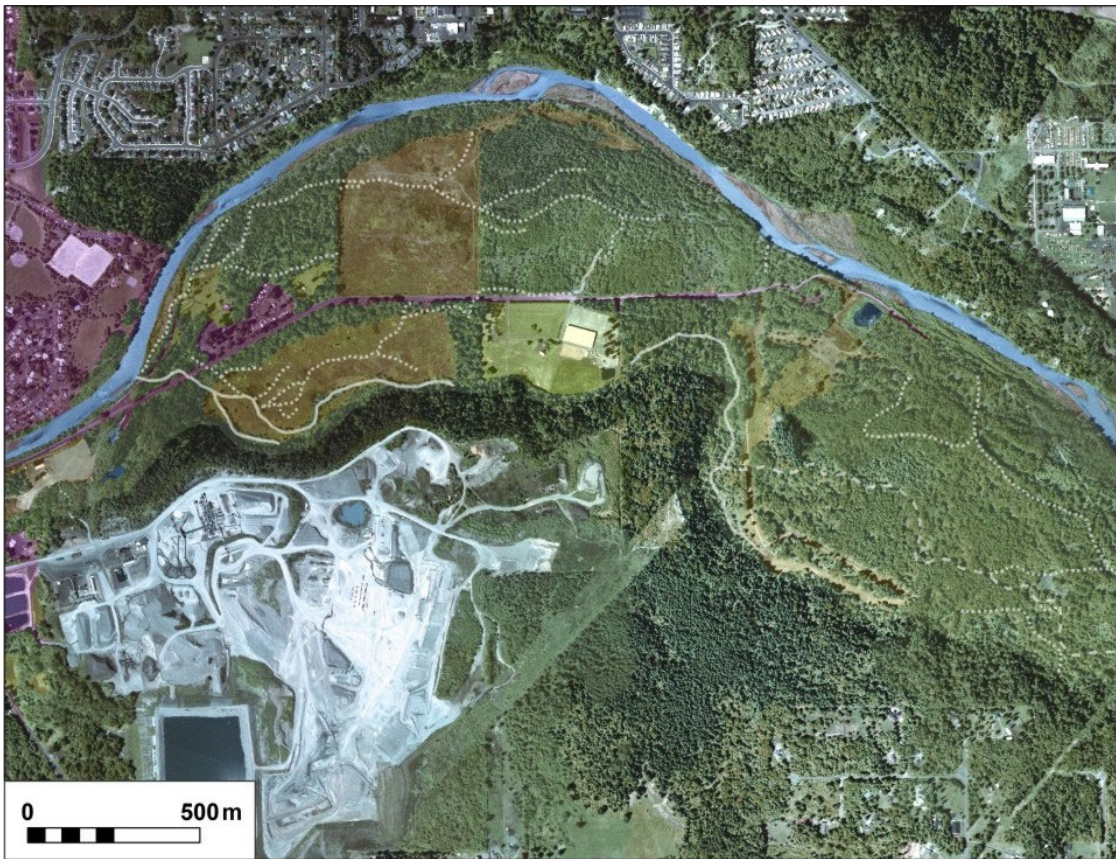
Figure 5 (following 11 pages). Paired sets of aerial photographs from 1936 (upper panel on each page) and 2000 (lower panel on each page), sequenced from downstream to upstream. Yellow dashed lines and yellow numbers indicate segment boundaries and segment numbers, as described in text. Photographs are overlain by GIS coverages. All photographs are oriented with north at top of page. Colors and channels are as in Figure 4, except that “revetment” is shown with a crosshatch pattern.

The active channel area and channel width increased substantially in the period between the GLO mapping and the 1931 and 1936 aerial photographs (Figures 5A-5K). The active channel decreased in all segments from 1936 to 2000, as illustrated in Figure 5 and quantified in Figure 6. Channel areas in the 1930s are between two and four times greater than the GLO-era channels (Figure 6). As described earlier in the “methods” section of this report, GLO plat maps generally depict the channel as wider than measured in the field, and the discrepancy varied locally, but it is likely that the GLO maps overestimate the actual channel area, which would cause the magnitude of pre-1930s channel widening in Figure 6 to be an underestimate. On the other hand, while we believe there is strong evidence supporting our interpretation that GLO channels represent the active channel (i.e., including low-flow channel, bare gravel bars, and gravel bars with colonizing vegetation), we do not know how consistently this convention was observed. However, it is likely that the channel drawn on GLO plat maps is a reasonably accurate representation of the active channel.

Levees built in segments 1 and 2 may have had some influence on channel area (see Figure 5B and 5C). The channel area remained constant in segment 1 after levees were built (“L1” in Figure 6). However, segment 5, which lacks levees, showed a similar response (Figure 6; Figures 5G-K). In segment 2, where a levee was breached in the late 1970s (“L2” in Figure 6), the channel widened. However, the timing of this widening is similar to that in segment 4, and slightly different than that in segment 3.

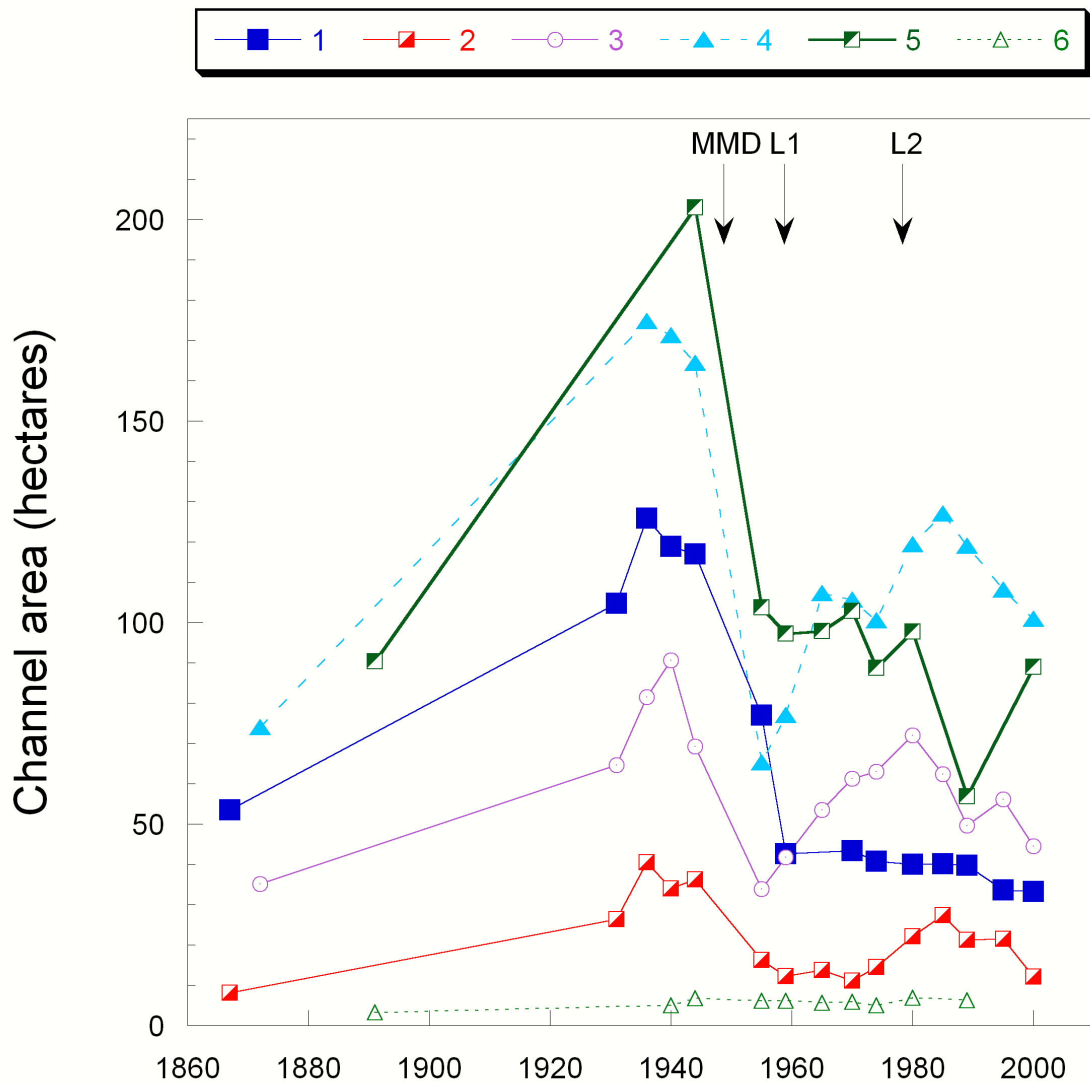
Figure 6. Area, in hectares, of active channel (low-flow channel, gravel bars, and colonizing vegetation on bars) versus time for six segments of the White River study area. Segment locations are shown in Figures 1 and 5. Area was measured from digitized aerial photographs except for earliest (19th century) data, which is from GLO plat maps. Years of map and aerial photograph coverage varies between segments. MMD = Mud Mountain Dam; L1 = levees built in segments 1 and 2; L2 = levee breached in segment 2.

The active channel area then diminished substantially from the 1931-1940 period, in all segments, in the subsequent two decades. The channel area in all cases diminished to the 1955-1959 period, in most

cases returning to channel areas similar to those first mapped by the GLO in the 19th century, with the exception of segment 6, which is a relatively confined reach. The channel area in some segments increased in segments 2, 3, and 4 after the 1955-1959 period, and decreased slightly in segments 1 and 5.
